DEPARTMENT OF TRANSPORTATION**DIVISION OF ENGINEERING SERVICES**

Contract #: 04-0120F4Cty: SF/ALA Rte: 80 PM: 13.2/13.9File #: 69.28**WELDING INSPECTION REPORT****Resident Engineer:**Pursell, Gary**Address:** 333 Burma Road**City:** Oakland, CA 94607**Report No:** WIR-001002**Date Inspected:** 07-Dec-2007**Project Name:** SAS Superstructure**OSM Arrival Time:** 630**Prime Contractor:** American Bridge/Fluor Enterprises, a JV**OSM Departure Time:** 1530**Contractor:** Zhenhua Port Machinery Company, Ltd (ZPMC), Changxing Island **Location:** Shanghai, China

Bridge No: 34-0006**Component:** Bay1- #1 Deck Mock-up and #2 Weld Trial**Summary of Items Observed:**

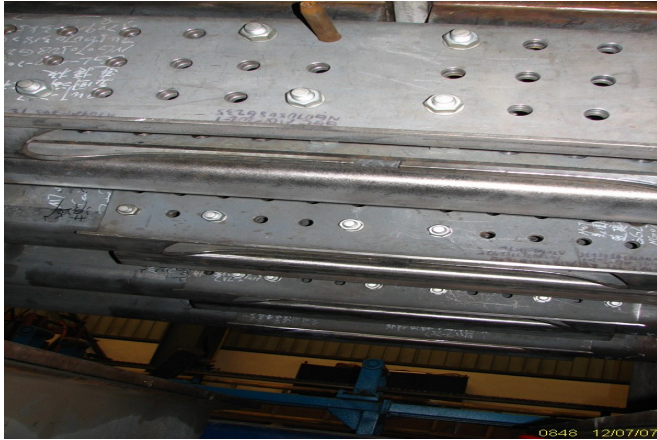
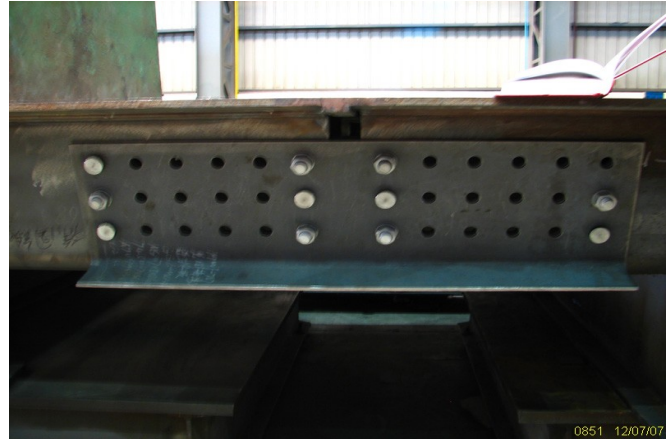
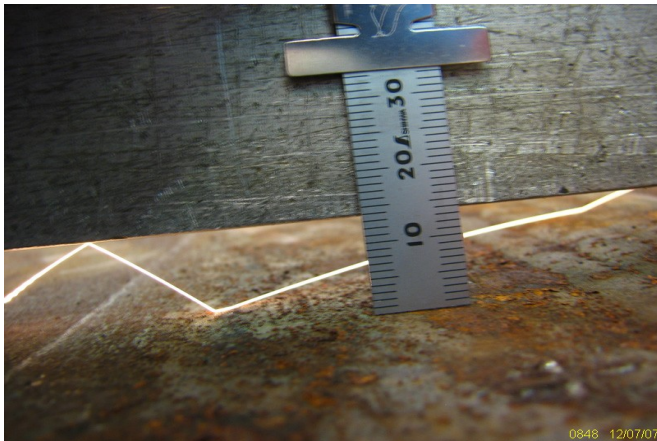
Observed Heat straightening operations for MUSB-MA22-89m Tower Mock-up. ZPMC was working to HSR1(CT) 164. ZPMC QC inspector was on site and checked temperatures throughout the process while the QA Inspector observed. Temperature indicator for 593 degrees C did not melt even though pyrometer temperatures

were viewed between 350-595 degrees C. A deflection of 14mm was noted at the beginning of this operation. The HSR report indicated a repair for "about 7 mm". ABF inspector, Jeff Evans, was notified of the findings and he relayed that 14mm was a definite nonconforming issue. Further action is pending by ZPMC and ABF. Several areas of heat straightening are apparent. It appears that heat straightening operations are a normal part of the manufacturing process based on daily observations.

Electrode Storage Room- The weld issue logs are still written in Chinese characters after several attempts to rectify them. Temperatures appear to be within parameters for storage.
